# VEHICLE INSPECTION REPORT

**SJ15UBR**

## Vauxhall Vivaro 2900 1.6CDTI 115PS

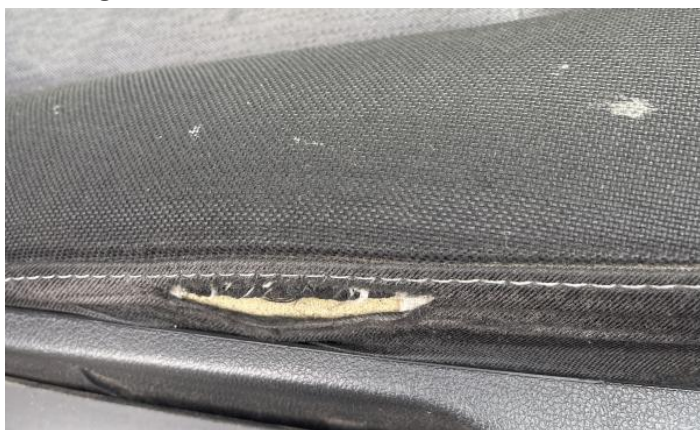
1: Seat Base Cover of  
Torn  
Over 3mm

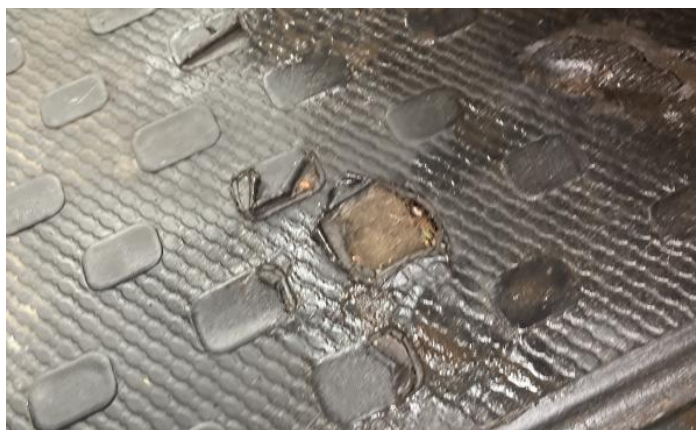
2: Carpets Front  
Torn  
Over 10mm

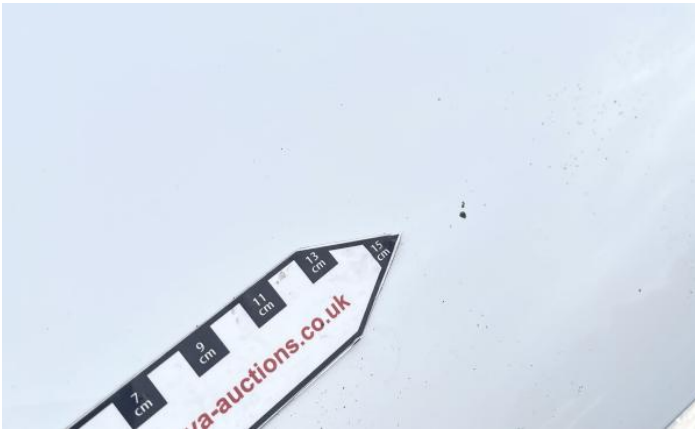
3: Bonnet  
Chipped  
Multiple Chips

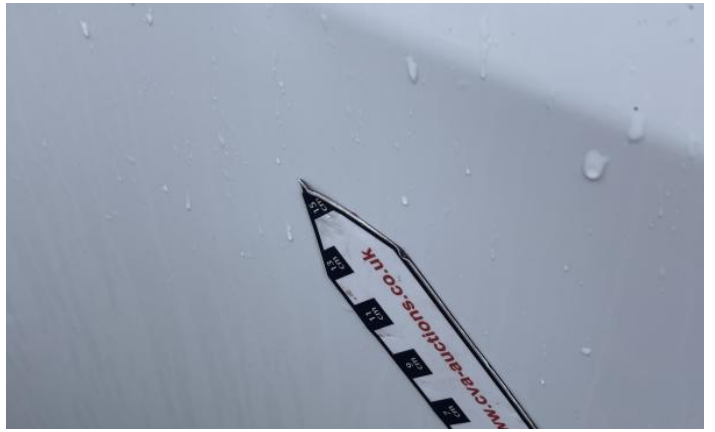
4: Door osf  
Dented  
Over 30mm

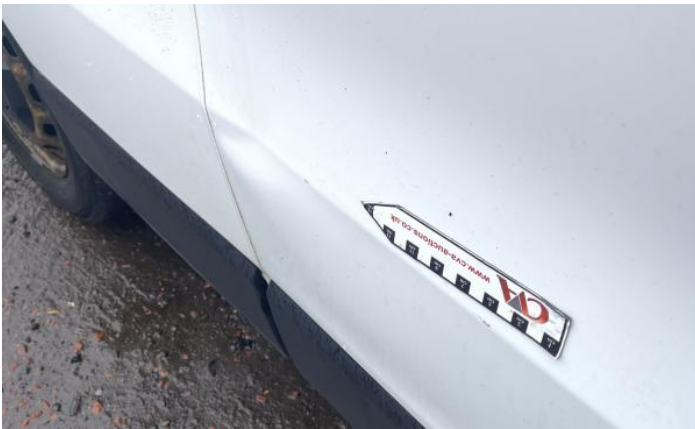
5: Qtr Panel osr  
Dented  
With Paint Damage

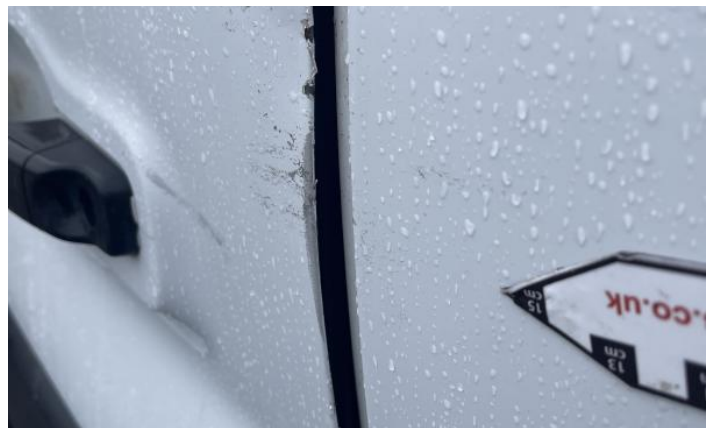
6: Tailgate  
Dented  
With Paint Damage

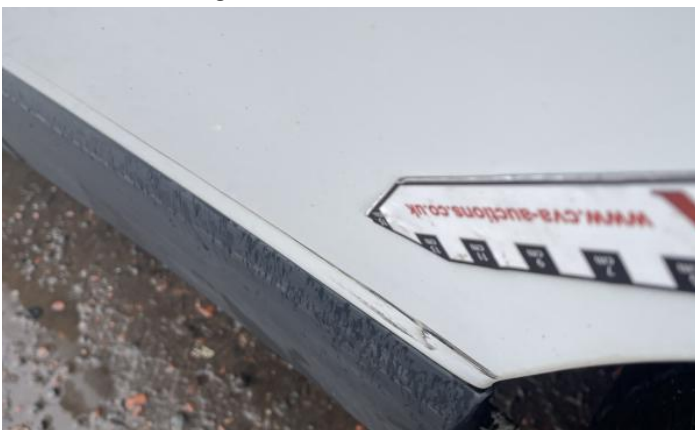
7: Qtr Panel nsr  
Dented  
With Paint Damage

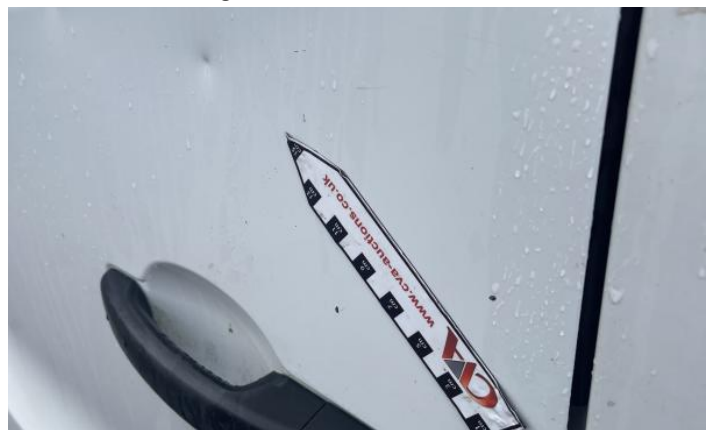
8: Door nsf  
Dented  
With Paint Damage
